ROOFING FOR HISTORIC BUILDINGS

Slate

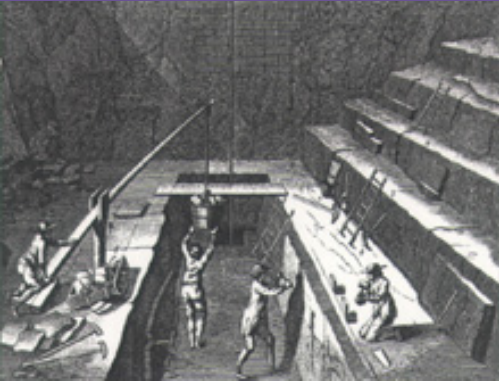
Mineralogie, Ardoises D'Anjou. Travail de la Carriere Ouverte et Outils. **Revuelli de Planches, sue Les Sciences, Les Arts Liberaux, et Les Arts Mechaniques, Avec Explication**, Diderot-D'Alembert. (Courtesy of NewsBank, Inc.) [click image for larger view]

Until the 1870s the quarrying of slate changed little from what is illustrated by Diderot in the **Pictorial Encyclopedia of Science Art and Technology** of 1762. Blocks were separated from the floor of the quarry using picks, wedges, prybars and gunpowder, taking maximum advantage of the natural seams in the rock. Windlasses and simple cranes employed man or horse power to lift blocks of slate from the pit. With the Industrial Revolution came mechanical drills and steam-powered stone channeling machines and hoists. Waste associated with blasting was reduced and efficiency increased. Subsequent advances were marked by the introduction of the wire saw in 1926 and the diamond belt saw in 1988.
